# CRITICAL HABITAT AREAS OF PATRICK LAKE, ADAMS COUNTY, WISCONSIN DECEMBER 2006

# **CRITICAL HABITAT DESIGNATION**For Patrick Lake, Adams County 2006

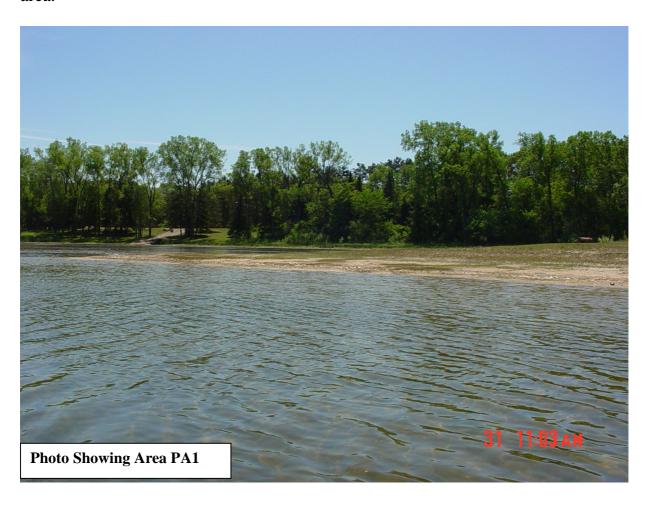
This area extends along approximately 800 feet of the shoreline. Sediment includes muck and silt. 70% of the shore is native herbaceous vegetation; 23.3% of the shore is cultivated lawn; the remaining shore is hard structure. There are downed logs in the water that provide fish and wildlife cover. Filamentous algae were found in this area. There is a moderate level of human disturbance at this area.

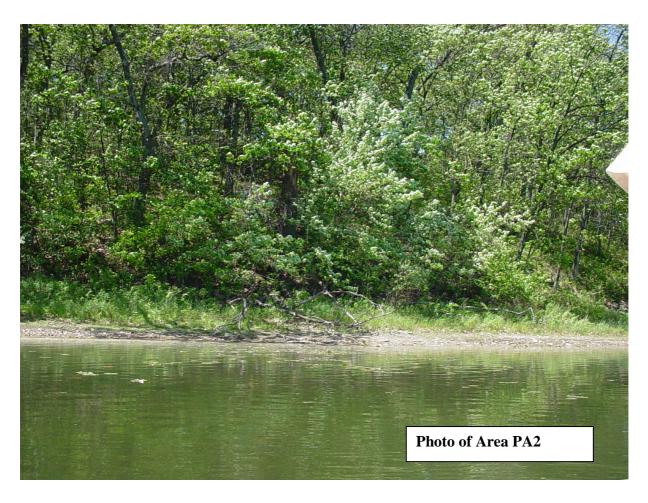
This area extends along approximately 1000 feet of the shoreline. Sediment includes peat, sand, silt and mixtures thereof. 25% of the shore is wooded; 10% has shrubs; 45% is native herbaceous cover. The remaining shore is cultivated lawn and hard structure. Large woody cover is common in the shallow water for habitat.

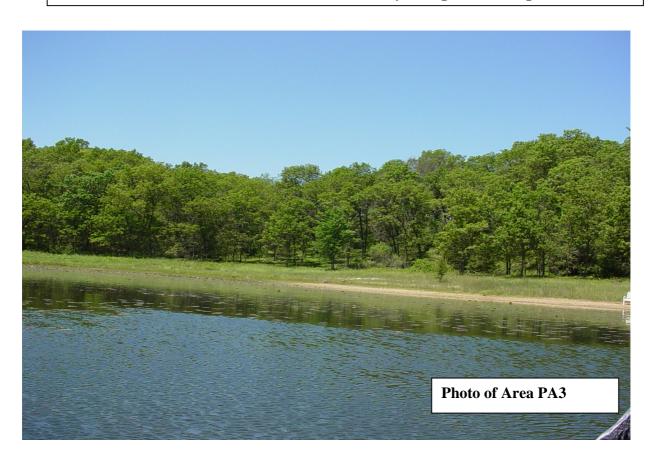
This area extends along approximately 1650 feet of the shoreline. Sediment includes marl, muck, peat, sand, silt and mixtures thereof. 6.7% of the shore is wooded; 5% has shrubs; 85% is native herbaceous cover—the remaining is cultivated lawn. Large woody cover is present in shallow water for fish and wildlife cover. Scenic beauty in part of the area is lessened due to the human development.
